**Flood Control Project Maintenance  
Levee Inspections**

**Fall 2012 Levee Maintenance Deficiency Summary Report**

**Lake County Watershed Protection District**

**Levee Inspection Report By Mile - Fall 2012**

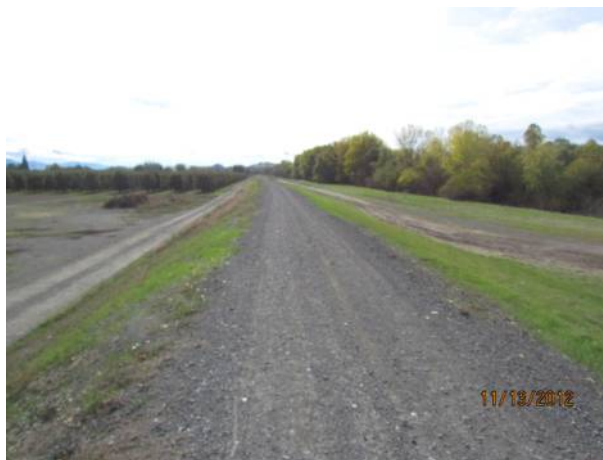
Levee Mile Report Line	4
Start Levee Mile	1.75
End Levee Mile	1.75
Location	Land Side
Category	Earthen Levee
Item	Vegetation

View of no vegetation on both slopes.

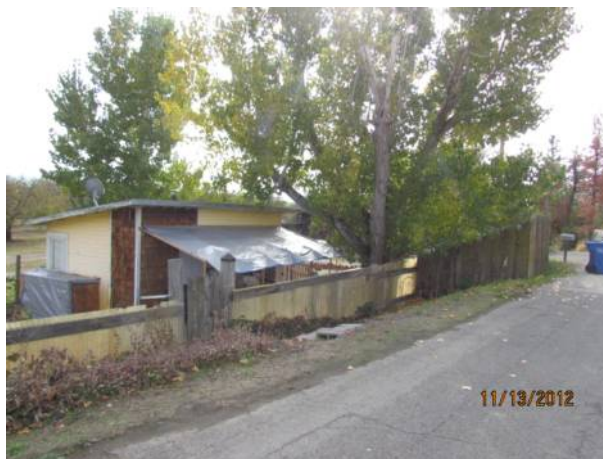
Levee Mile Report Line	5
Start Levee Mile	2.40
End Levee Mile	2.40
Location	Land Side
Category	Earthen Levee
Item	Encroachments

View of a building & fence along the toe of the levee.

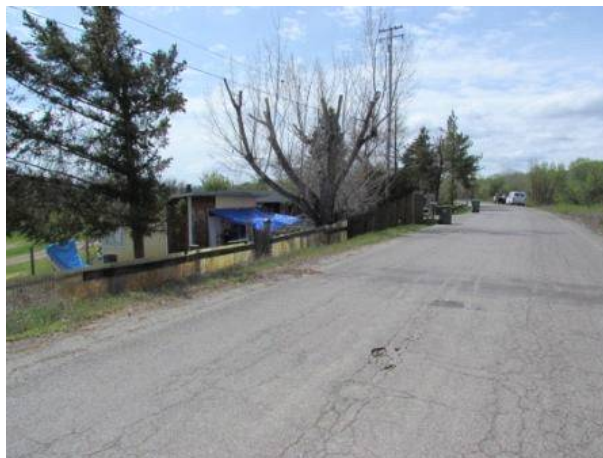
Levee Mile Report Line	7
Start Levee Mile	2.58
End Levee Mile	2.61
Location	Land Side
Category	Earthen Levee
Item	Encroachments

View of the fences at the L/S toe.

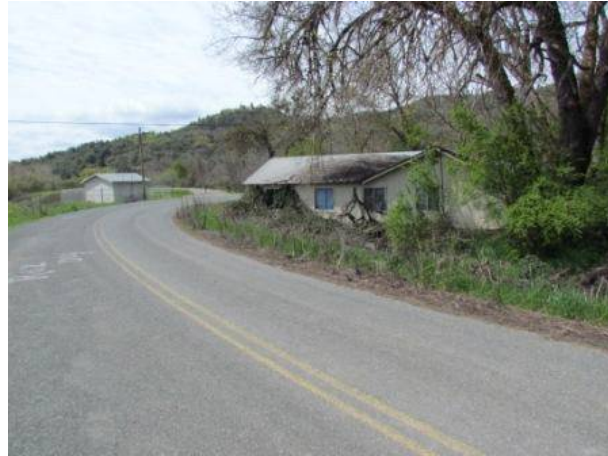
Levee Mile Report Line	1
Start Levee Mile	0.20
End Levee Mile	0.20
Location	Land Side
Category	Earthen Levee
Item	Encroachments

View of the vegetation and building next to the landside toe of levee.

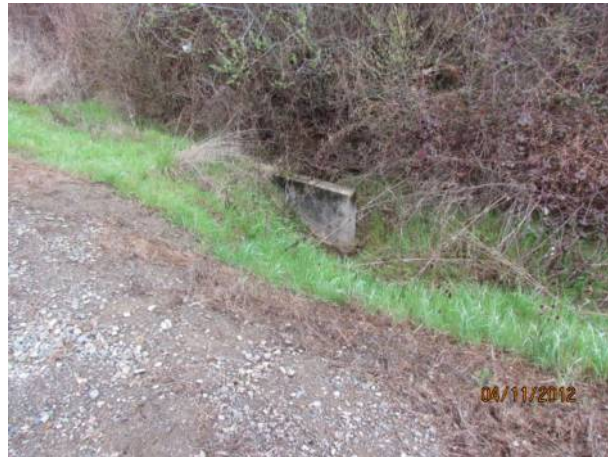
Levee Mile Report Line	2
Start Levee Mile	0.39
End Levee Mile	0.39
Location	Land Side
Category	Earthen Levee
Item	Slope Stability

View of erosion along slope of the levee by both sides of the headwall.

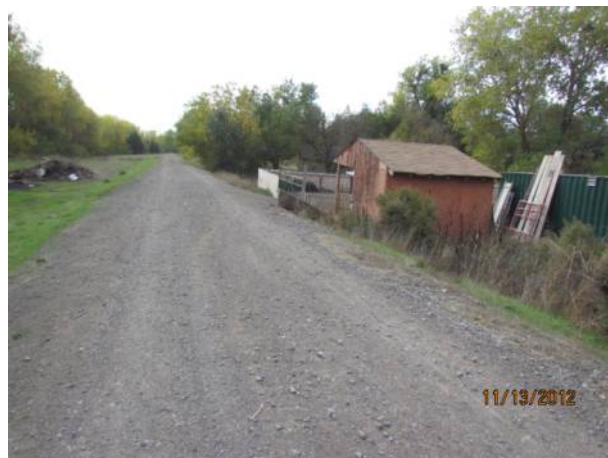
Levee Mile Report Line	4
Start Levee Mile	1.05
End Levee Mile	1.05
Location	Land Side
Category	Earthen Levee
Item	Encroachments

View of building & vegetation along the levee toe.

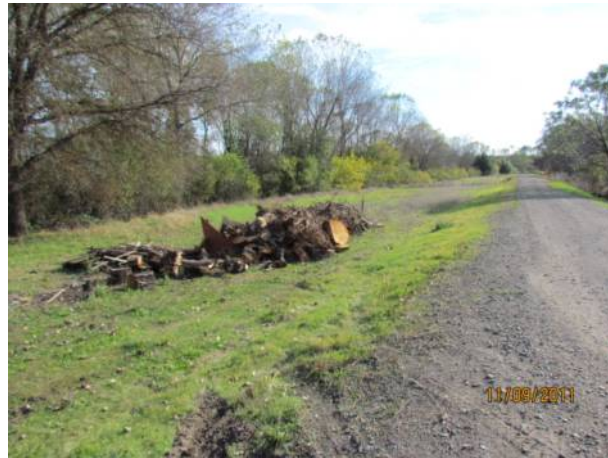
Levee Mile Report Line	5
Start Levee Mile	1.06
End Levee Mile	1.06
Location	Land Side
Category	Earthen Levee
Item	Encroachments

View of the tree prunings on the W/S toe.

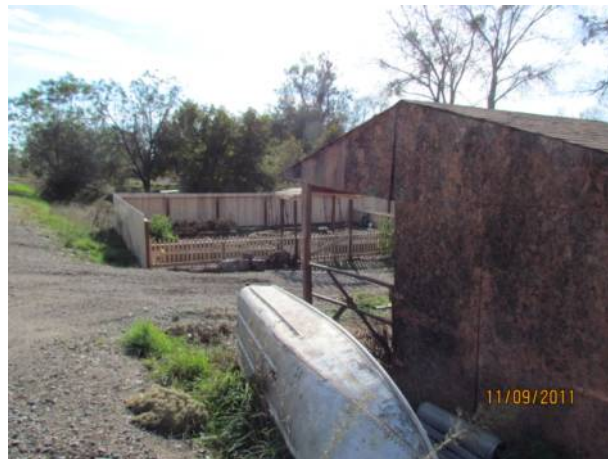
Levee Mile Report Line	6
Start Levee Mile	1.06
End Levee Mile	1.06
Location	Land Side
Category	Earthen Levee
Item	Encroachments

View of the building & fence along the L/S toe.

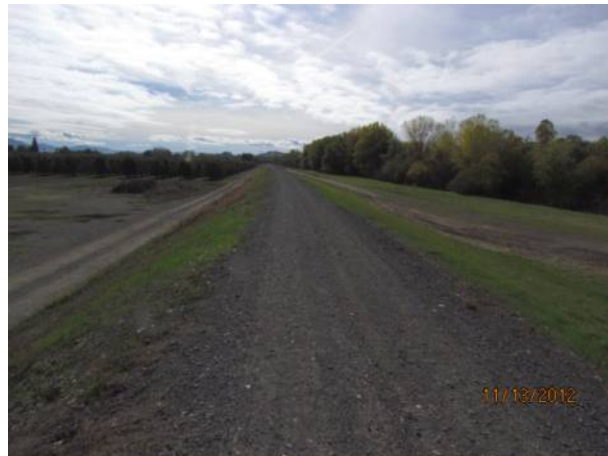
Levee Mile Report Line	7
Start Levee Mile	1.19
End Levee Mile	1.19
Location	Land Side
Category	Earthen Levee
Item	Vegetation

View of no vegetation on both slopes.

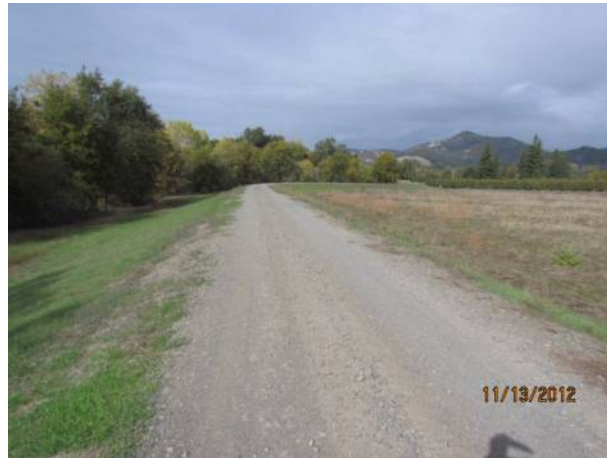
Levee Mile Report Line	1
Start Levee Mile	0.53
End Levee Mile	0.53
Location	Land Side
Category	Earthen Levee
Item	Vegetation

View of the no vegetation on both slopes.

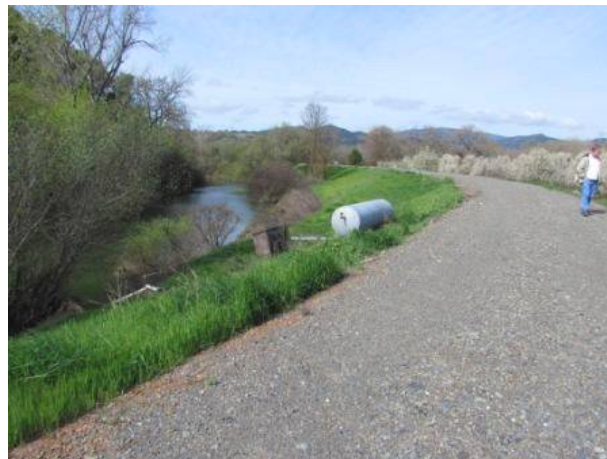
Levee Mile Report Line	2
Start Levee Mile	0.97
End Levee Mile	0.97
Location	Water Side
Category	Earthen Levee
Item	Encroachments

View of a tank that needs to be removed from the W/S slope.

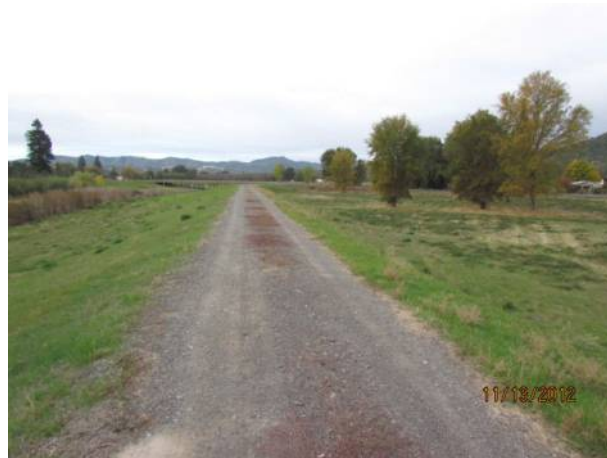
Levee Mile Report Line	1
Start Levee Mile	0.64
End Levee Mile	0.64
Location	Land Side
Category	Earthen Levee
Item	Vegetation

View of the levee with all vegetation removed.

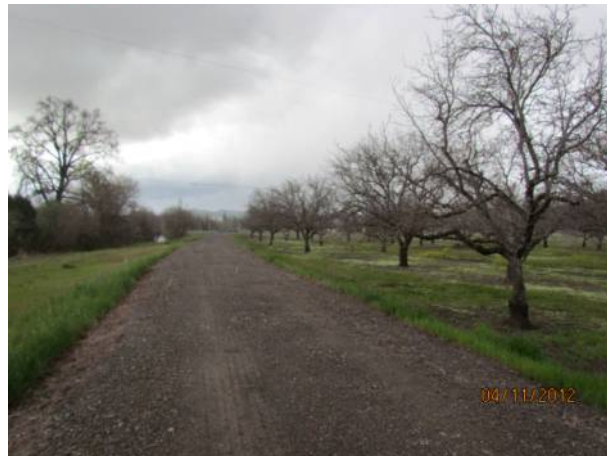
Levee Mile Report Line	4
Start Levee Mile	1.19
End Levee Mile	1.19
Location	Land Side
Category	Earthen Levee
Item	Encroachments

View of the walnut tree prunings along the toe of the levee.

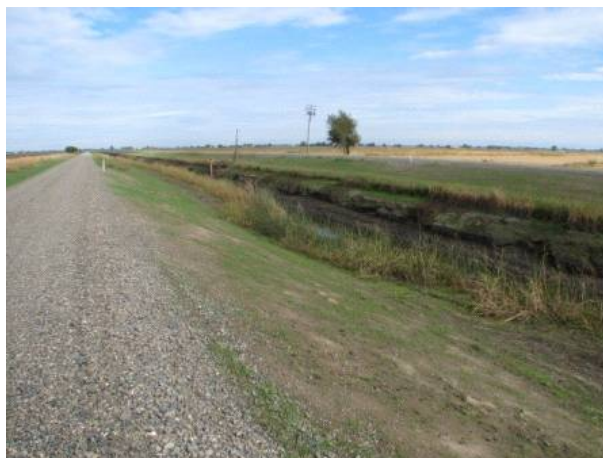
Levee Mile Report Line	1
Start Levee Mile	0.30
End Levee Mile	0.30
Location	Land Side
Category	Earthen Levee
Item	Vegetation

View of the elderberries along the landside toe of the levee.

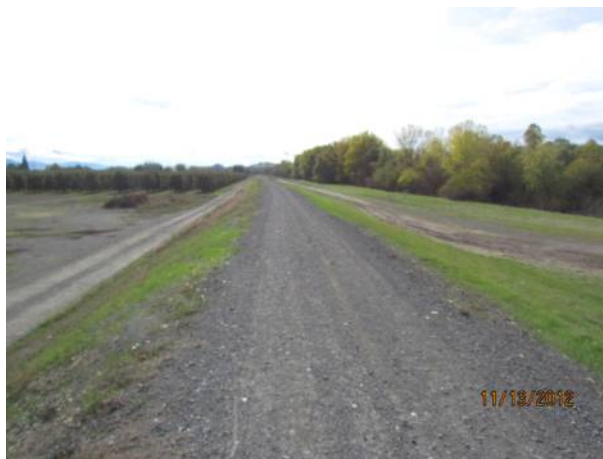
Levee Mile Report Line	2
Start Levee Mile	0.88
End Levee Mile	0.88
Location	Land Side
Category	Earthen Levee
Item	Vegetation

View of on vegetation on both slopes.
